Gargrave Erosion Study

– Key findings

‘QXE-JBA-XX-XX-RP-EN-0001-S2-P01-
Gargrave_Erosion_Scoping_Report’

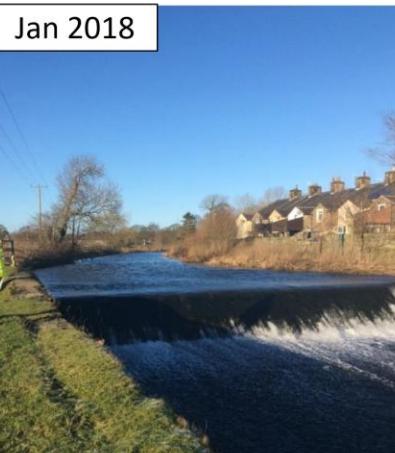
Low energy, depositional conditions upstream of weir.

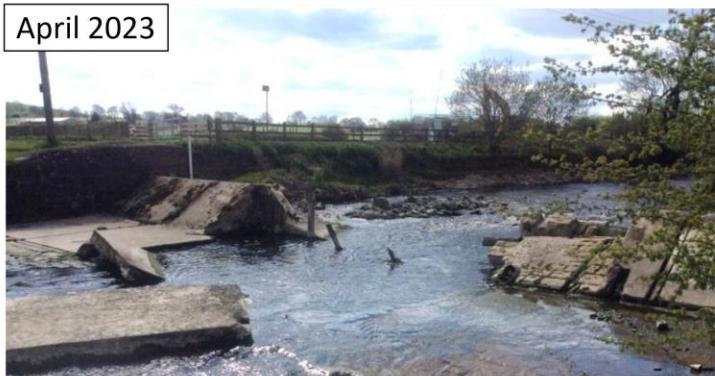
Bed level dropped by approx. 1.5m following collapse in 2022 → caused bed instability as the channel attempts to re-gain a stable gradient → knick-point erosion (head-cut) tracked up-stream.

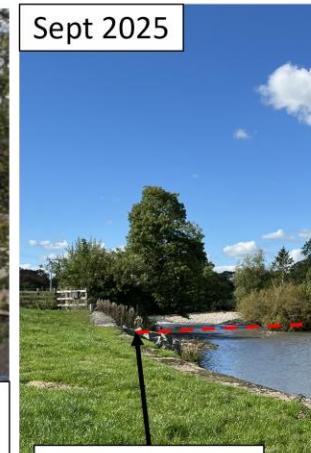
Approx. crest of collapsed weir.

Right bank concrete protection prevents lateral erosion, promoting local bed erosion → deeper glide flow.

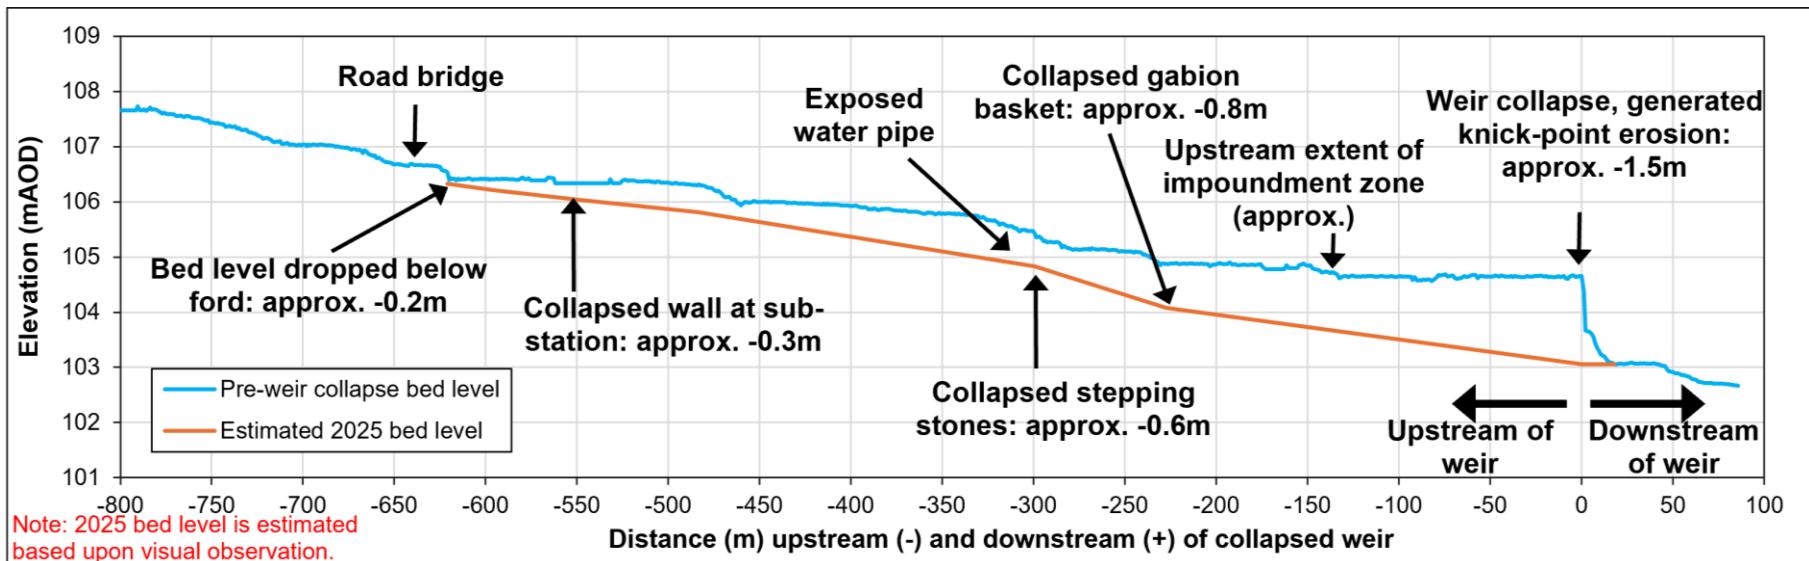
Bed profile of the knick-point erosion

- Weir collapse triggered a knick-point (head cut) erosion to be transmitted upstream.
- Riverbed incision (erosion) into the mobile sediment built up upstream of the weir.
- The river is attempting to regain a natural bed longitudinal profile.
- Drop in bed level has (and is) causing bank instability.

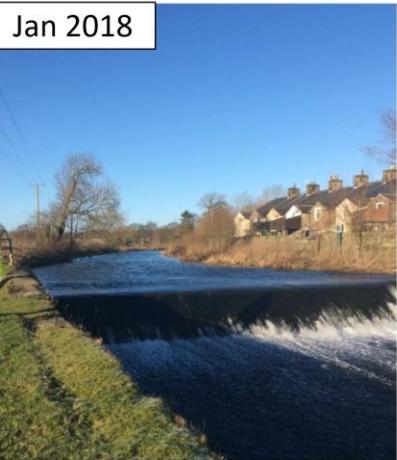
Jan 2018

Low energy, depositional conditions upstream of weir.

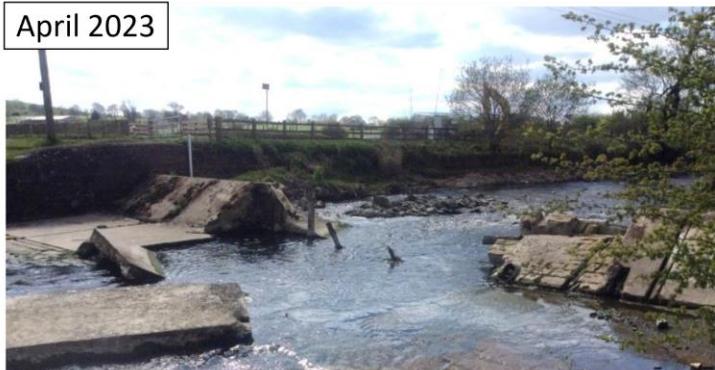
April 2023

Bed level dropped by approx. 1.5m following collapse in 2022 → caused bed instability as the channel attempts to re-gain a stable gradient → knick-point erosion (head-cut) tracked up-stream.

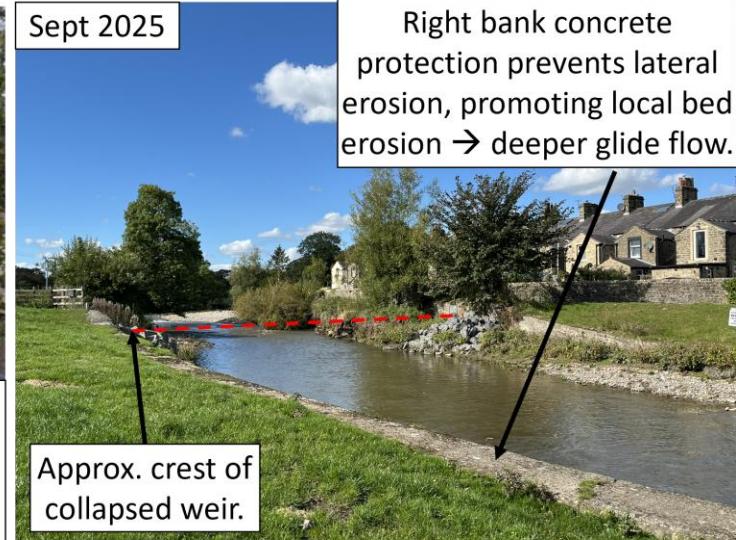
Sept 2025

Right bank concrete protection prevents lateral erosion, promoting local bed erosion → deeper glide flow.

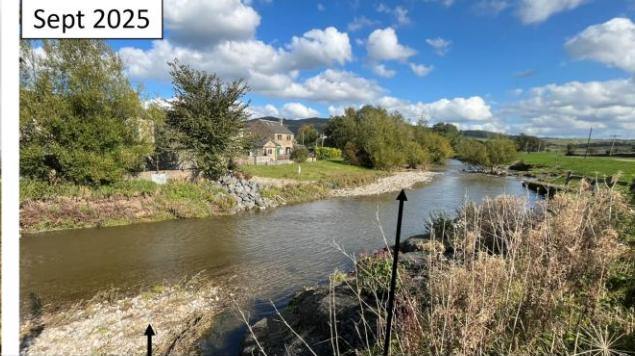
Sept 2025

Locally, the bed may have generally stabilised here → development of depositional bar features → however, bars are migratory, and patterns / magnitudes of erosion and deposition may shift over time.

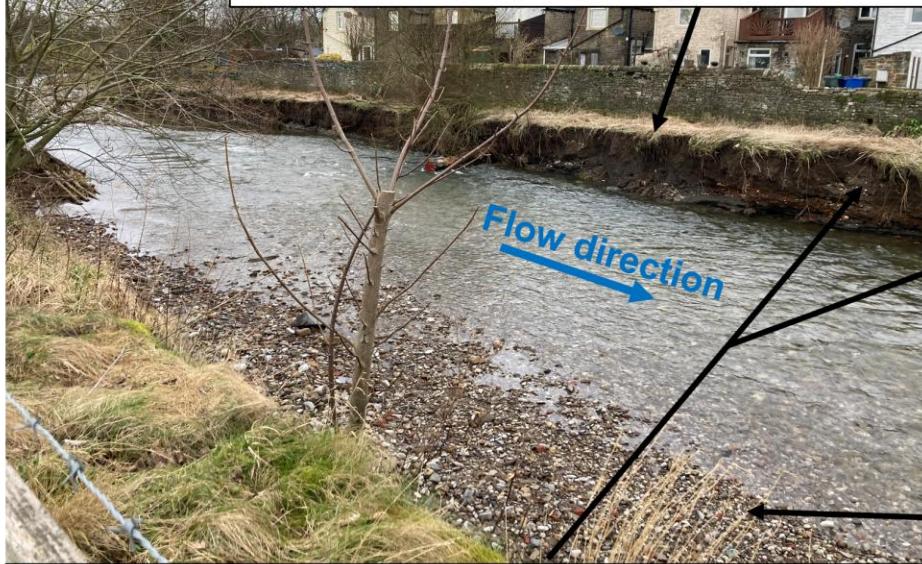
Jan 2024

Channel bed level has dropped by approx. 1.5m immediately upstream of the collapsed weir, exposing faces of alluvial material on the left and right banks.

Since weir collapse and bed level adjustment, the left bank does not appear to have undergone significant further change.

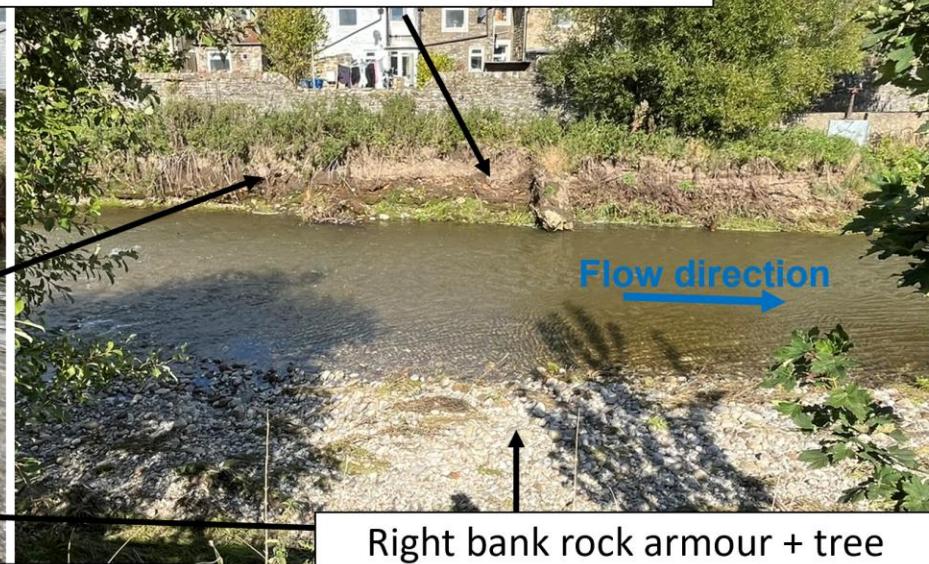
Sept 2025

Right bank rock armour + tree roots create a lower energy zone, forming a small gravel bar.

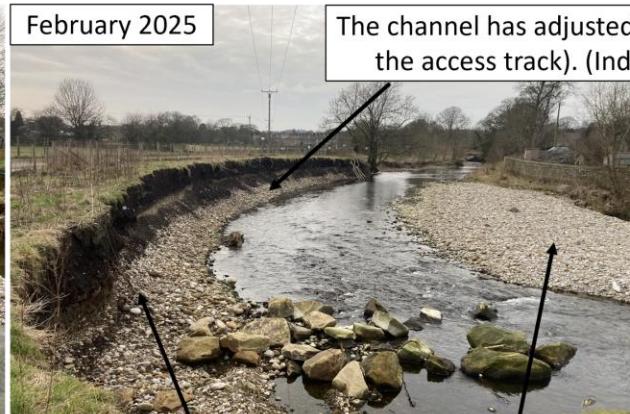
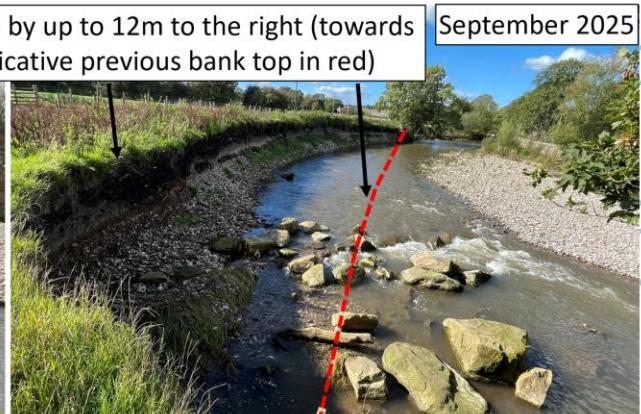
The channel has adjusted by up to 12m to the right (towards the access track). (Indicative previous bank top in red)

Increased channel gradient with weir collapse increases flow energy → enabling scour of right bank alluvial material → deposition on the inside of the meander bend pushes energy towards the right bank, promoting scour.

The left bank does not appear to be continuing to erode following the initial bed level adjustment. However, patterns of erosion and deposition may change over time.

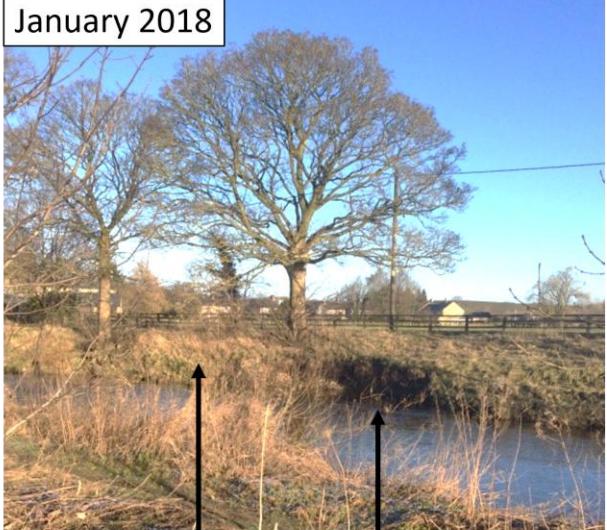
January 2018

Pre-weir collapse, moderate pockets of bank erosion existed on the outside of the bend (left bank), but banks were largely vegetated and stable.

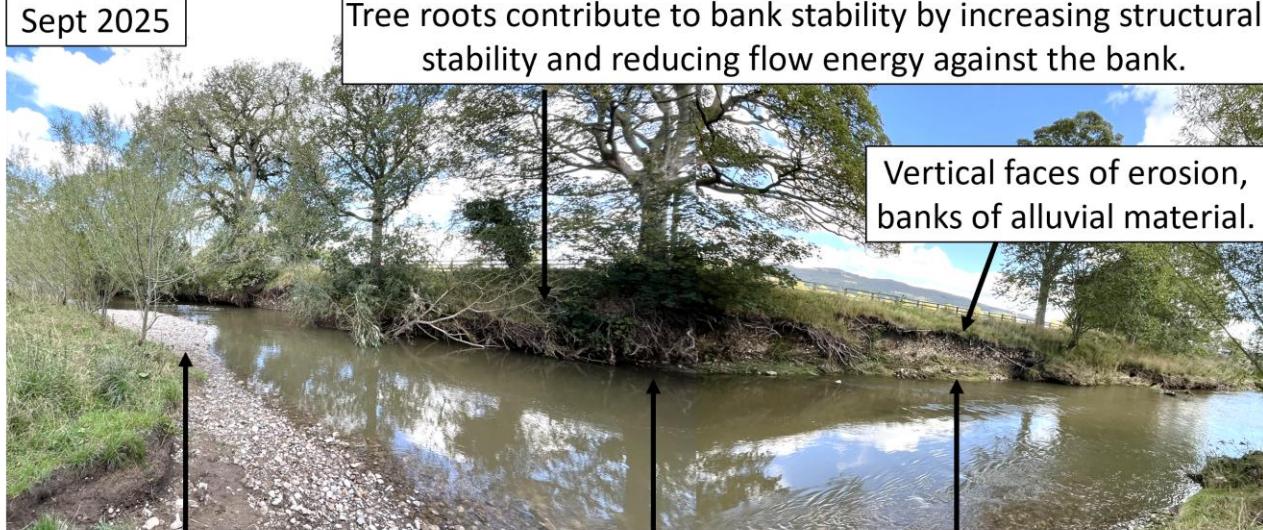
Sept 2025

Tree roots contribute to bank stability by increasing structural stability and reducing flow energy against the bank.

Vertical faces of erosion, banks of alluvial material.

Increased sediment flux through the reach may be contributing to increased deposition on inside of the meander bend → pushing flow energy towards the outside of the bend.

With upstream progression of the knick-point erosion, bed levels dropped creating steeper banks with exposed alluvium + flow energy increased due to the increased channel gradient → causing bank erosion and undercutting of trees → channel has shifted towards Mill Lane.

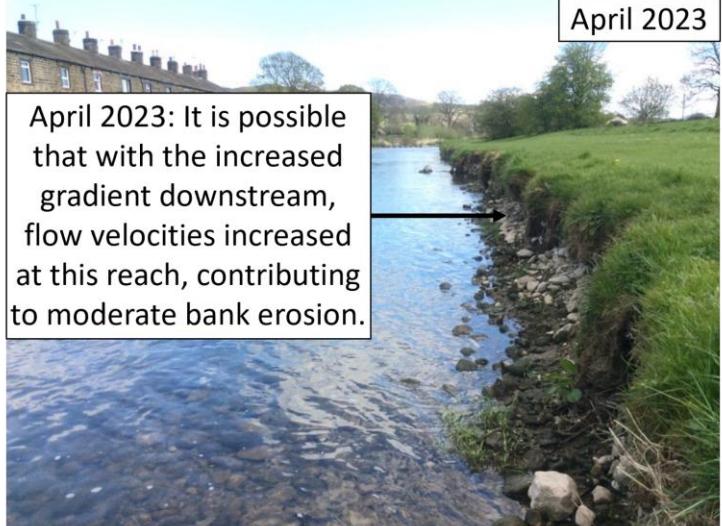
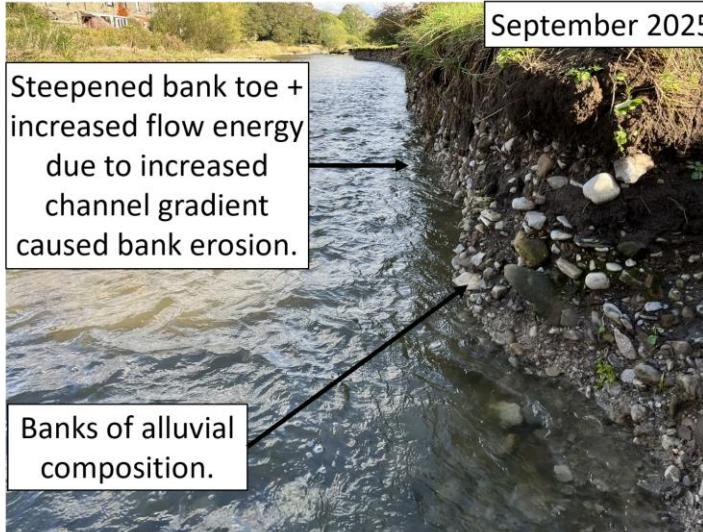
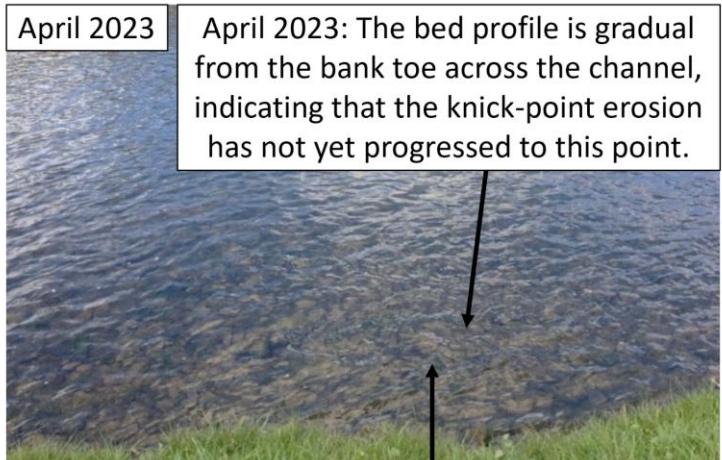
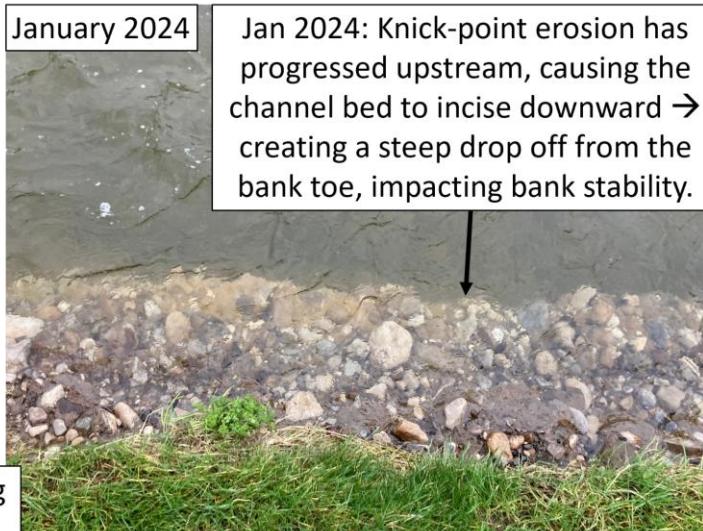
450m upstream of the collapsed weir – right bank erosion through the park

April 2023: Bed material has algal covering, indicating infrequent mobilisation, prior to knick-point erosion.

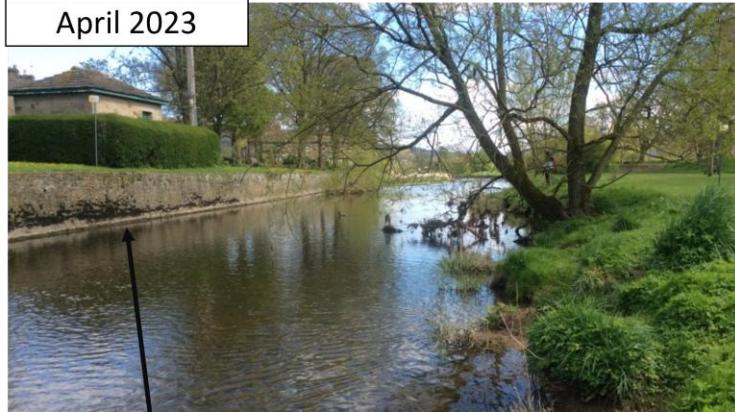
September 2025 wall collapse at substation

April 2023: The knick-point erosion has not yet progressed up to this point - bed levels generally unchanged compared to pre-weir collapse.

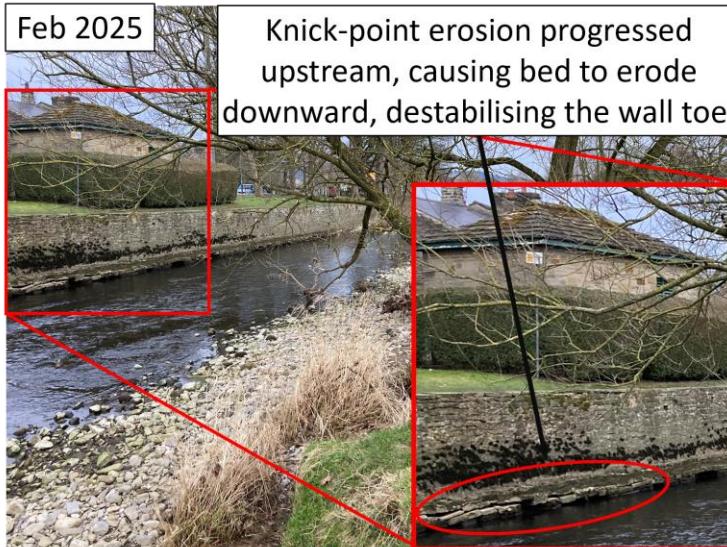
Knick-point erosion progressed upstream, causing bed to erode downward, destabilising the wall toe.

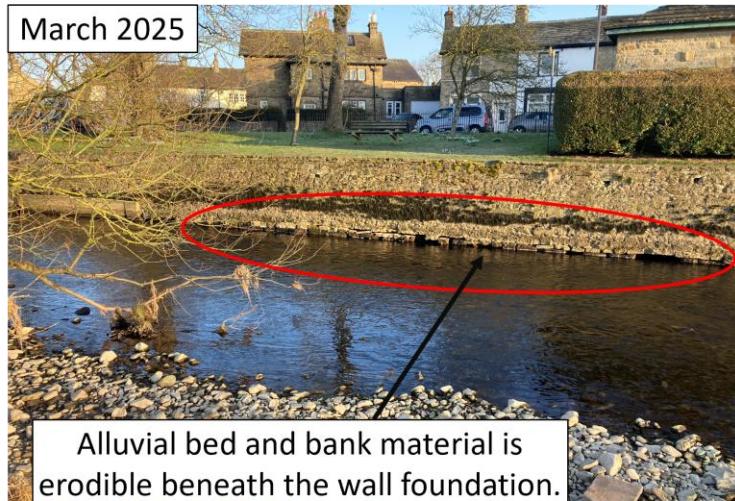
Alluvial bed and bank material is erodible beneath the wall foundation.

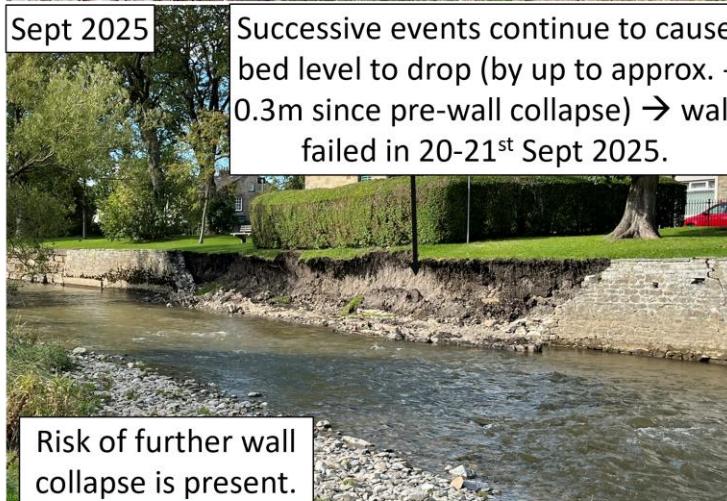
Successive events continue to cause bed level to drop (by up to approx. -0.3m since pre-wall collapse) → wall failed in 20-21st Sept 2025.

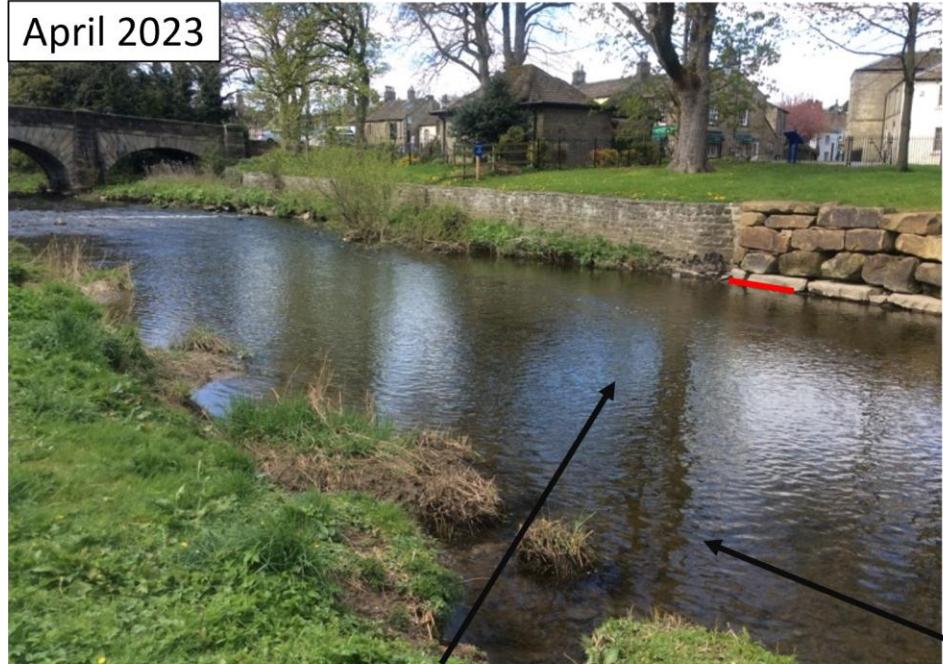
April 2023

April 2023: The knick-point erosion has not yet progressed up to this point - bed levels generally unchanged compared to pre-weir collapse.

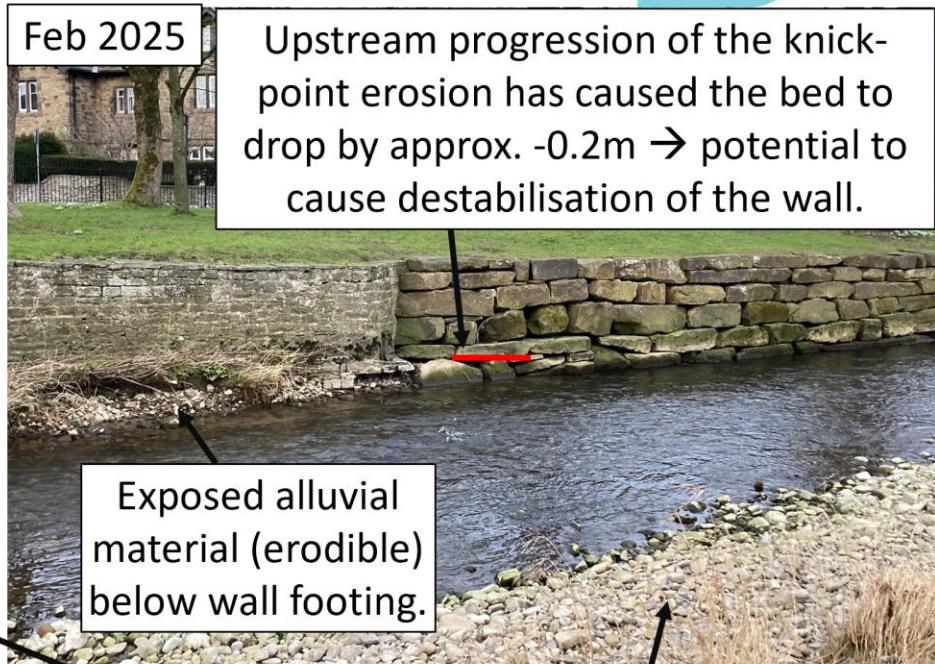
Feb 2025

Upstream progression of the knick-point erosion has caused the bed to drop by approx. -0.2m → potential to cause destabilisation of the wall.

Bed material was previously largely non-mobile, indicated by algal + silt covering. Increased flow energy with increased channel gradient has increased sediment mobility, bar material is now clean.

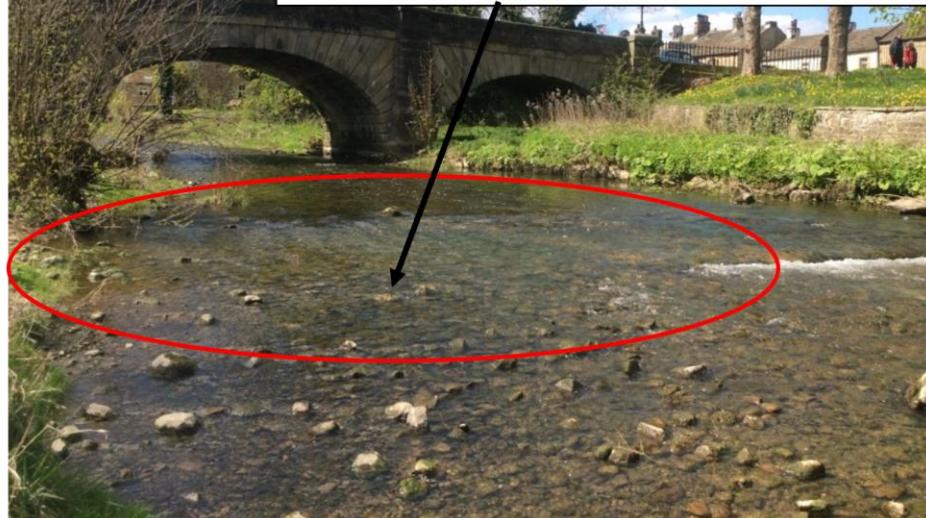
April 2023

Bed level has dropped on the downstream side of the ford structure → due to knick-point erosion → this structure may currently be controlling the upstream extent of the head cut.

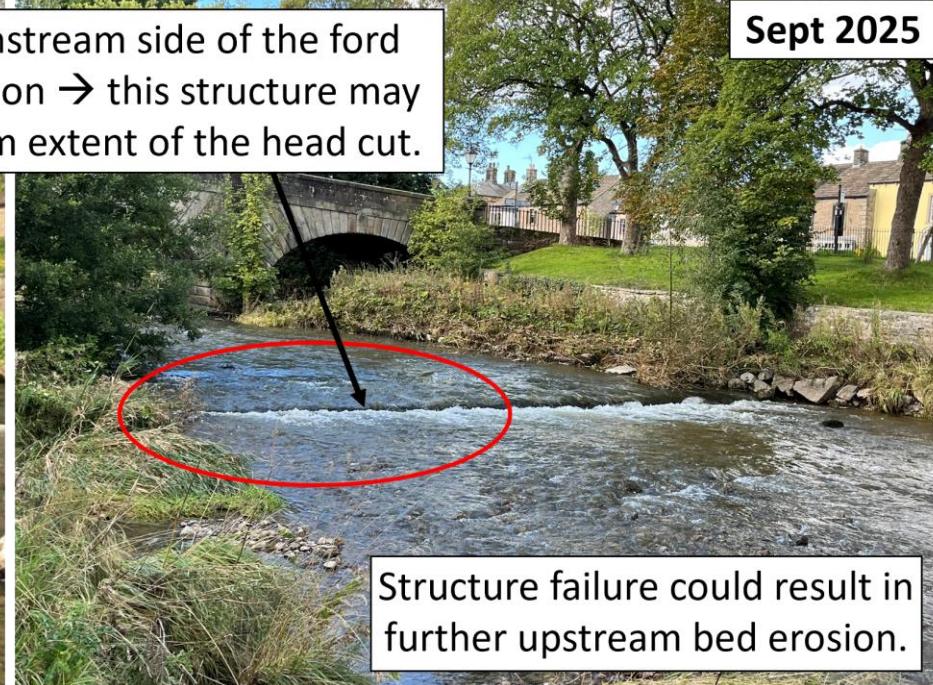
Sept 2025

Structure failure could result in further upstream bed erosion.

- Small boulder and cobble protection of the downstream toe of the ford.
- Control undermining + collapse of stone ford, mitigating risk of upstream migration of knick-point erosion.

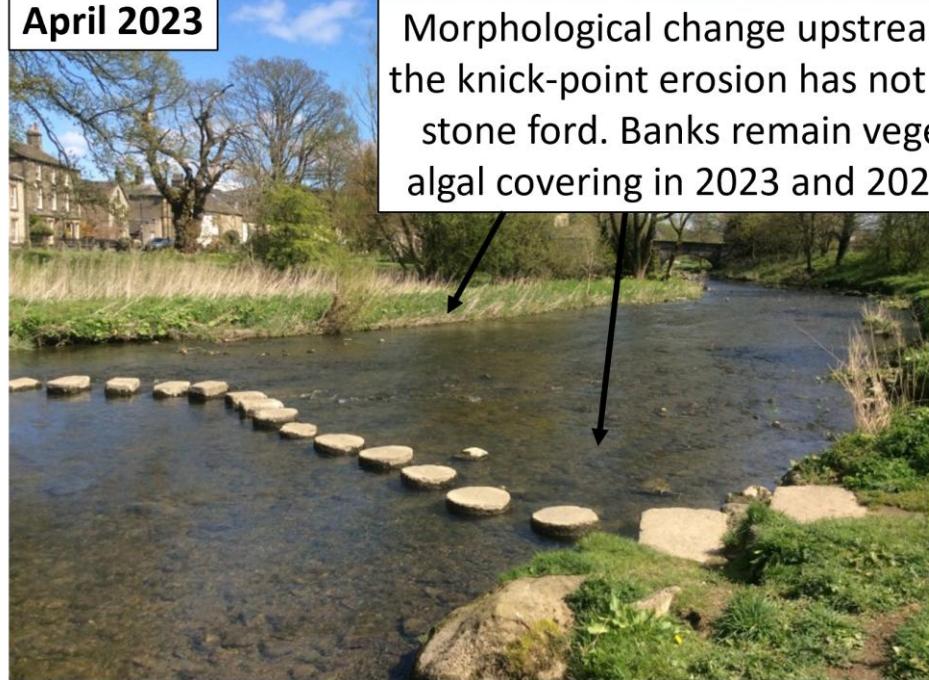
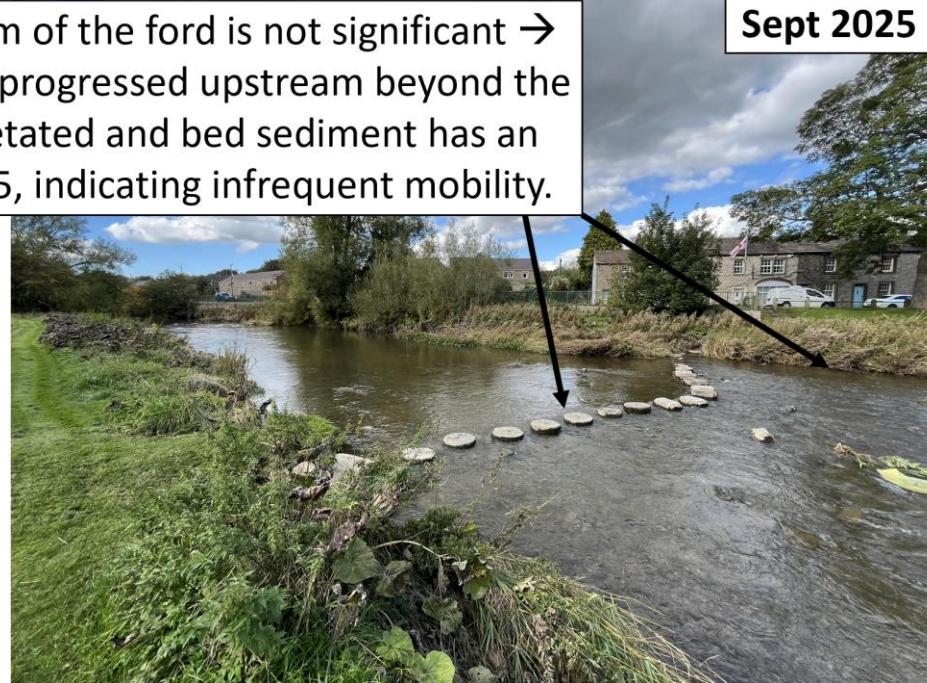
780m upstream of the collapsed weir – upstream stepping stones

Morphological change upstream of the ford is not significant → the knick-point erosion has not progressed upstream beyond the stone ford. Banks remain vegetated and bed sediment has an algal covering in 2023 and 2025, indicating infrequent mobility.
