Gargrave Erosion Study

– Key findings

‘QXE-JBA-XX-XX-RP-EN-0001-S2-P01-
Gargrave_Erosion_Scoping_Report’

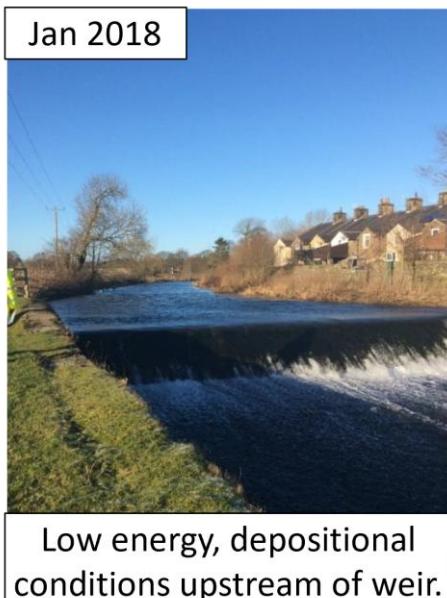
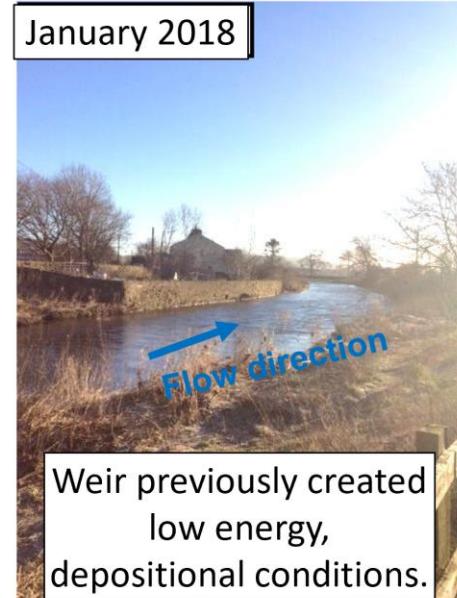
Pre-weir collapse conditions

- The Aire through Gargrave has been modified, suppressing flow energy and controlling bank erosion, via:
 - The weir
 - Channel straightening
 - Bank protection

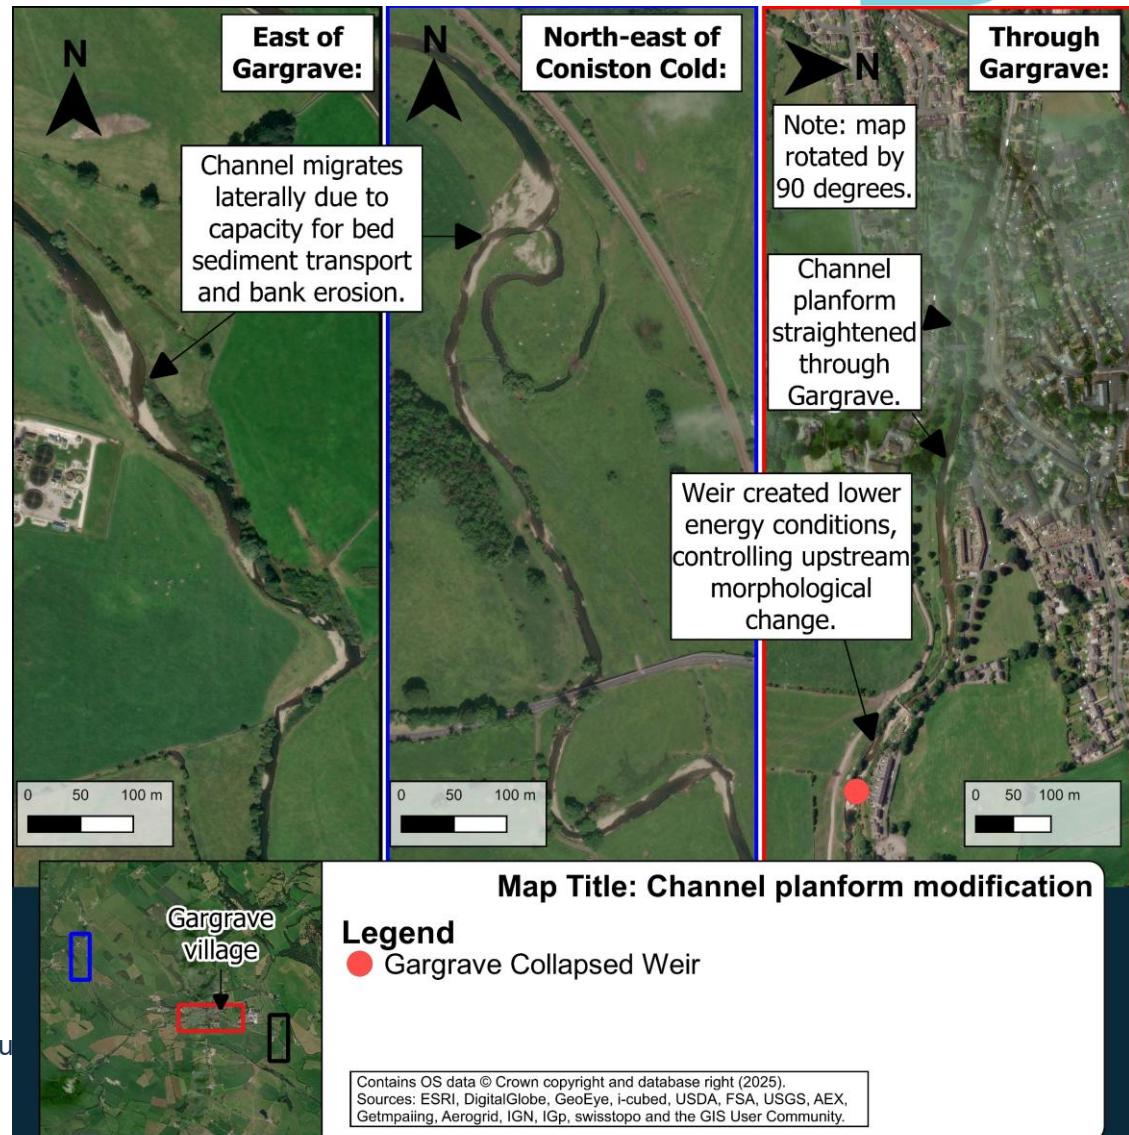
Knick-point (head-cut) erosion

- Weir collapse triggered a knick-point (head cut) erosion to be transmitted upstream.
- Riverbed incision (erosion) into the mobile sediment built up upstream of the weir.
- The river is attempting to regain a natural bed longitudinal profile.
- Drop in bed level has (and is) causing bank instability.

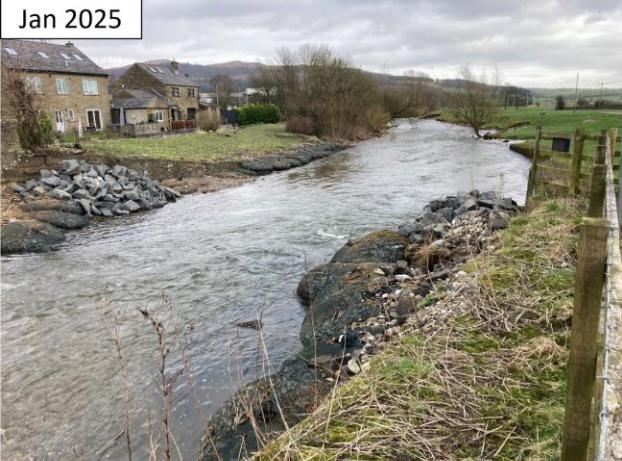
Feb 2025

Right bank concrete protection prevents lateral erosion, promoting local bed erosion → deeper glide flow.

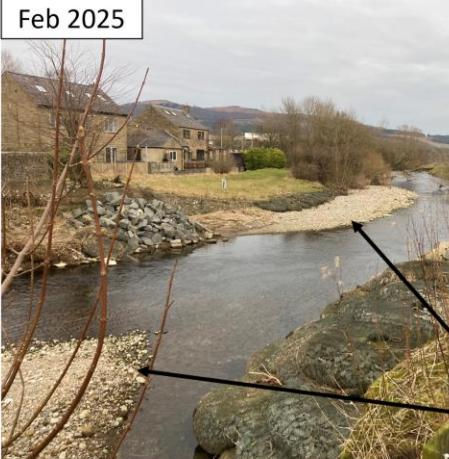
Sept 2025

Locally, the bed may have generally stabilised here → development of depositional bar features → however, bars are migratory, and patterns / magnitudes of erosion and deposition may shift over time.

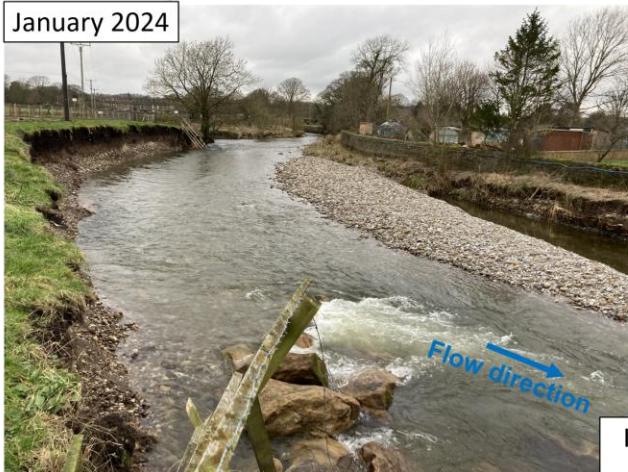
February 2025

The channel has adjusted by up to 12m to the right (towards the access track). (Indicative previous bank top in red)
